Tennant  
Canal  
Association  
History & Sustainability

## **Position Statement:**

## **Weir abstraction arrangement at Aberdulaish**

**Date: 21/04/22**

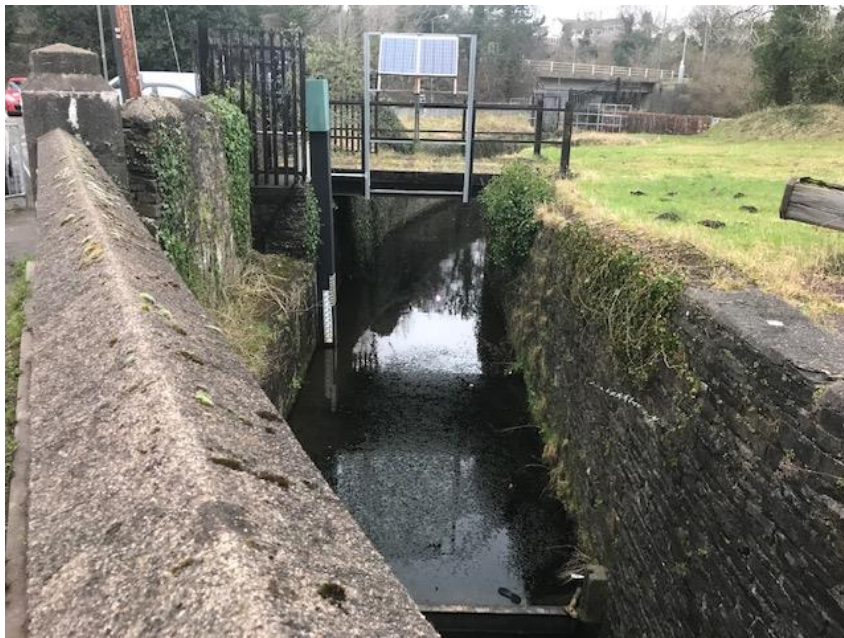
*Fig 1 - Tennant Canal Feeder Channel.*

It is assumed that the penstocks were manually modulated to regulate the flow from the Neath/Dulais and that they were completely closed at times of high river level to avoid contributing to flooding risk.

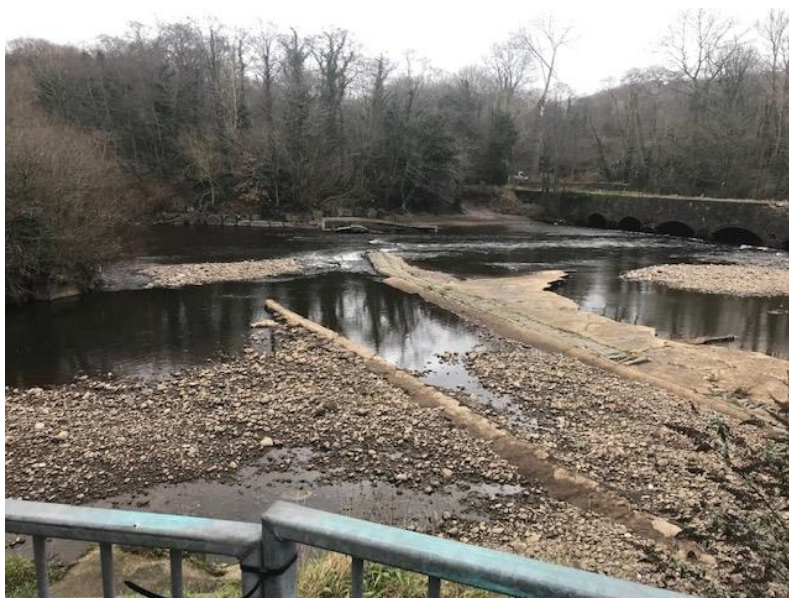
Subsequent to the weir being damaged the arrangement has fallen into disuse. The channel and forebay leading up to the penstocks are blocked with stones and sediment preventing any flow entering the feeder channel regardless of river levels (Figure 2 and Figure 3).

*Figure 2 - View of remaining weir and inlet channel showing sediment build up.*

The implications of the damage to the weir, silting of the channel and blockage of the penstock forebay are that the Tennant Canal no longer has a source of water from the Neath/Dulais confluence.

Unfortunately, the channel feeding the penstocks is currently completely blocked with stone and sediment, as is the penstock forebay. These should be cleaned out at the earliest opportunity as has been customary to allow flow to reach the penstocks. The inlet channel leading to the Tennant also requires cleaning out.

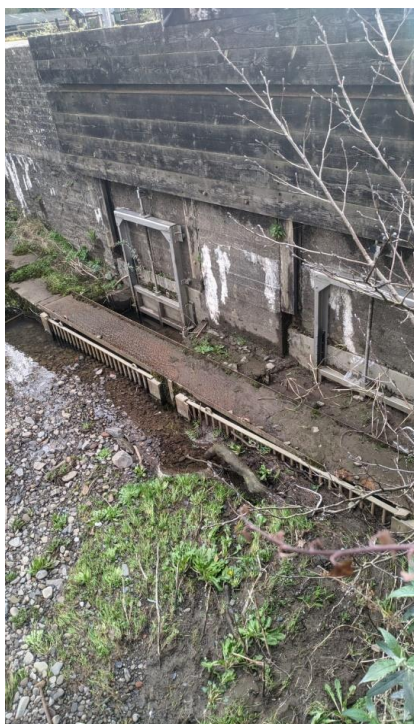
*Figure 3 - Penstocks at inlet to channel feeding the Tennant Canal – clearly non-functional due to stone/sediment accumulation.*

The concrete channel leading to the Tennant Canal will also require cleaning out to prevent large quantities of silt and mud entering the Tennant canal upon re-commissioning of the arrangement. Some repair work to the channel sidewalls is also required where masonry has failed. It is envisaged that some maintenance of the penstocks would be needed as they appear to have been inoperable for several years.

Maintenance and possible repair of the penstocks would be required, together with a review of the manual operating procedures to ensure adequate, reliable flow control, and closure of the penstocks at times of high river levels.

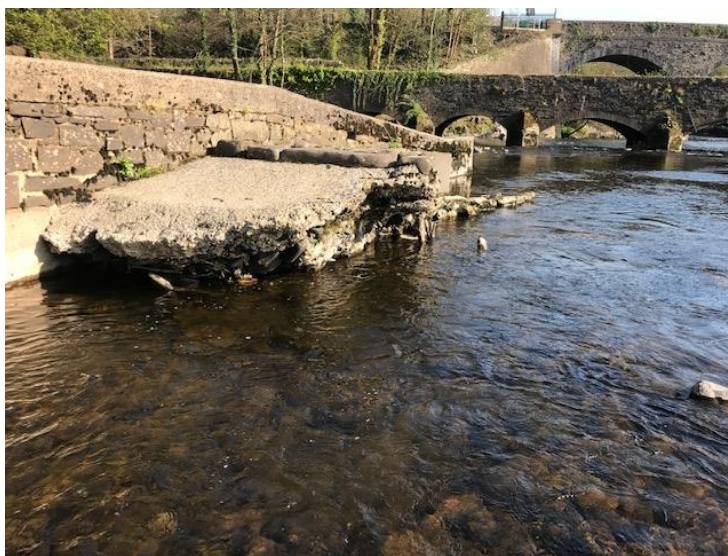
A fish pass was constructed on the Eastern side of the weir in 2002 (see Figure 4). The construction of this fish pass involved working on and alongside the weir and integrating the fish pass into the weir arrangement. Concerns regarding the impact of the fish pass on the impact on the weir and aqueduct were raised by Peter Ricketts of the Neath and Tennant Canal Preservation Society at the time of construction.

There is no indication from construction drawings, or visual inspection on-site, of proper provision for adequate tying in of the structure of the fish pass to the weir. Evidence from witnesses also suggests that very large tracked excavators were observed to be tracking on the top of the weir during the construction of the fish pass.

Site observations indicate that the weir failed at the interface between the original weir and the reconstructed section (believed to be the remaining length shown in Figure 4). This suggests that there was inadequate tying in of the original weir. There is no reference to tie bars on the drawings, and no evidence of such an arrangement on the remains. This suggests that a proper structural tying in detail was not utilised.

*TCA's view is that the construction of the fish pass has contributed to the failure of the weir.*

*Figure 4 - View of remaining weir alongside the fish pass.*

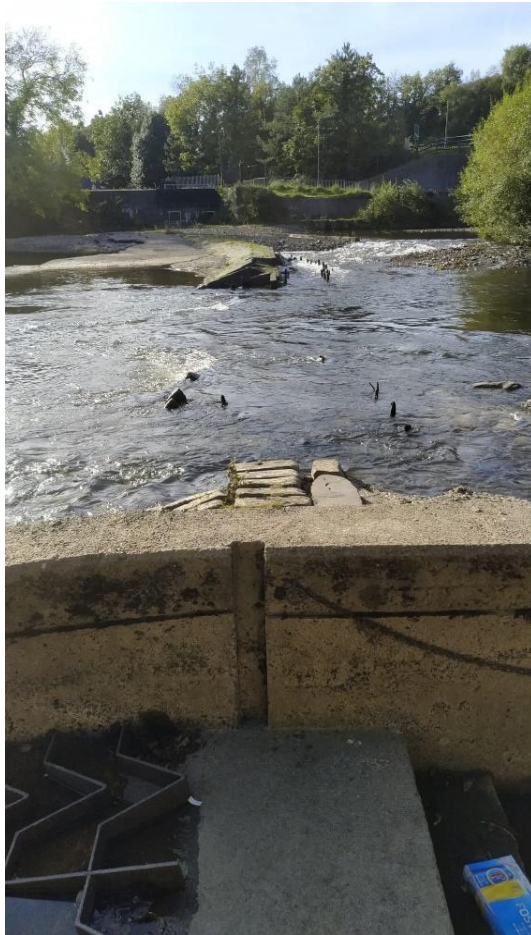
The section of weir on the Eastern side of the river was damaged in 2015. This prevents a full weir effect forming across the whole river. The weir is effectively breached (see Figure 5). As such the water levels at the entrance to the penstocks are not as high as required to ensure consistent flow through the penstocks into the canal.

The damage to the weir also currently negates the intended purpose of constructing the fish pass.

*Figure 5 - View along the damaged weir from the fish pass on the Eastern bank showing breach of the weir.*

Most of the remaining weir is in poor condition.

*TCA's primary position is that the weir should be fully reinstated to a condition that will provide a reliable water feed arrangement for years to come.*

Thirdly TCA proposes as the '*Complete*' solution, reinstatement of the weir to its historically correct condition (pre 2015).

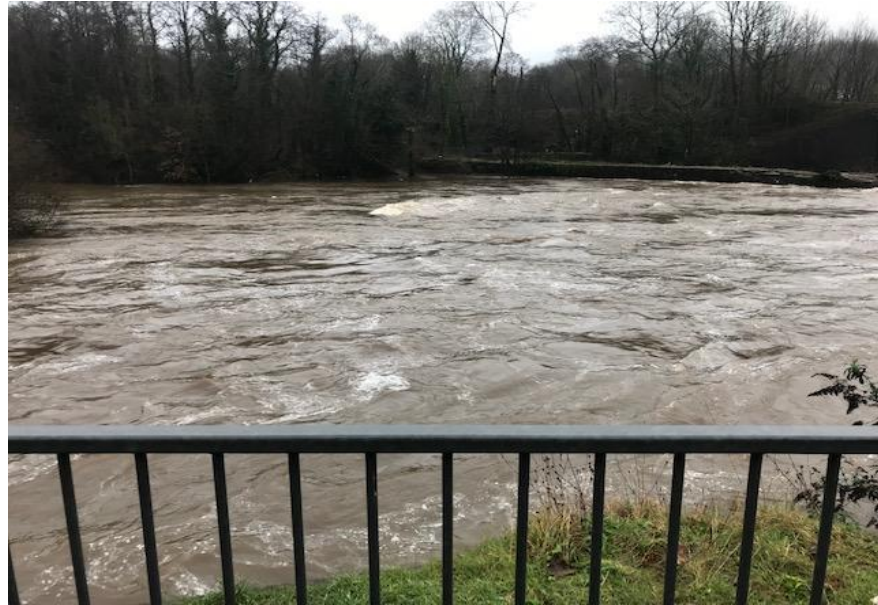
TCA's opinion is that the weir provided no or negligible restriction to river flow under imminent flood conditions. This is partially evidenced by a view across the weir (in its current state) in a reasonably high river level (well before risk of flooding to property occurs). Whilst this photograph (Figure 6) was taken prior to the weir damage, it does illustrate that there is no evidence of any significant hydraulic impact on upstream river levels across the remaining length of the weir.

As river levels rise further the effect will decrease even further as the weir gets increasingly drowned out.

*Figure 6 - View across weir from Eastern back illustrating negligible hydraulic impact of current arrangement in partial flood conditions.*

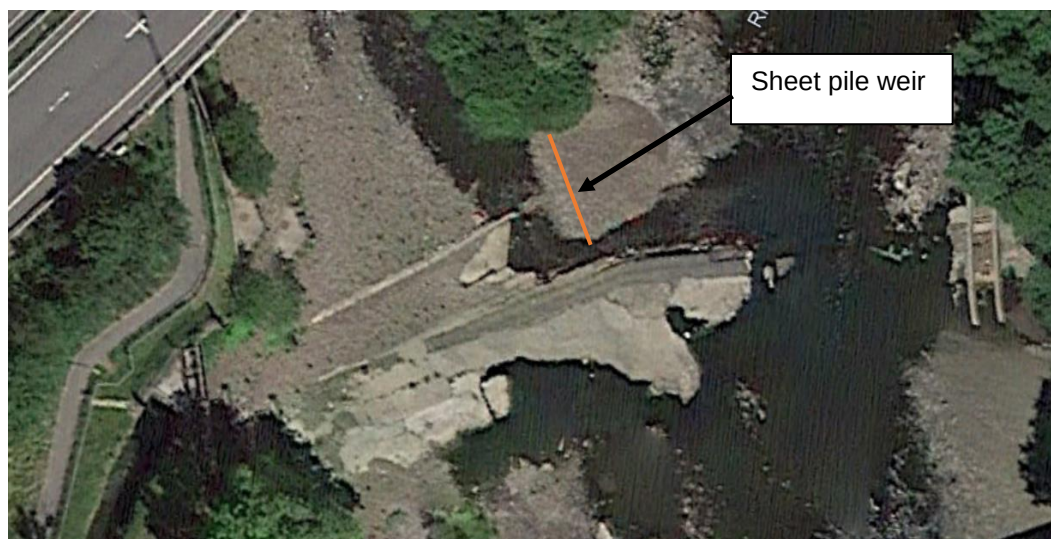
Most of the weir structure across the River Dulais exit is still in place and can function as a weir. There is a potential option to install a short length of sheet pile weir across the point where the River Dulais and River Neath meet (see Figure 7). This would effectively elevate the outlet level from the Dulais slightly, allowing the penstock forebay to flood in all conditions. It is likely that this weir could be set lower than the existing weir or curtailed for a short distance at one end to facilitate passage of migratory fish.

Figure 7 – Potential location of sheet pile weir

TCA view this as an expedient temporary solution and would still be seeking the full reintroduction of the weir.

As an '*interim*' solution, TCA proposes the consideration of the installation of a short sheet pile containment supporting the naturally occurring bank of stones. This is to ensure that the water level of the River Dulais at the location of the weir is surcharged sufficiently to allow flows to gravitate to the Tennant Canal. The naturally occurring bank of stones means that this is currently the case.

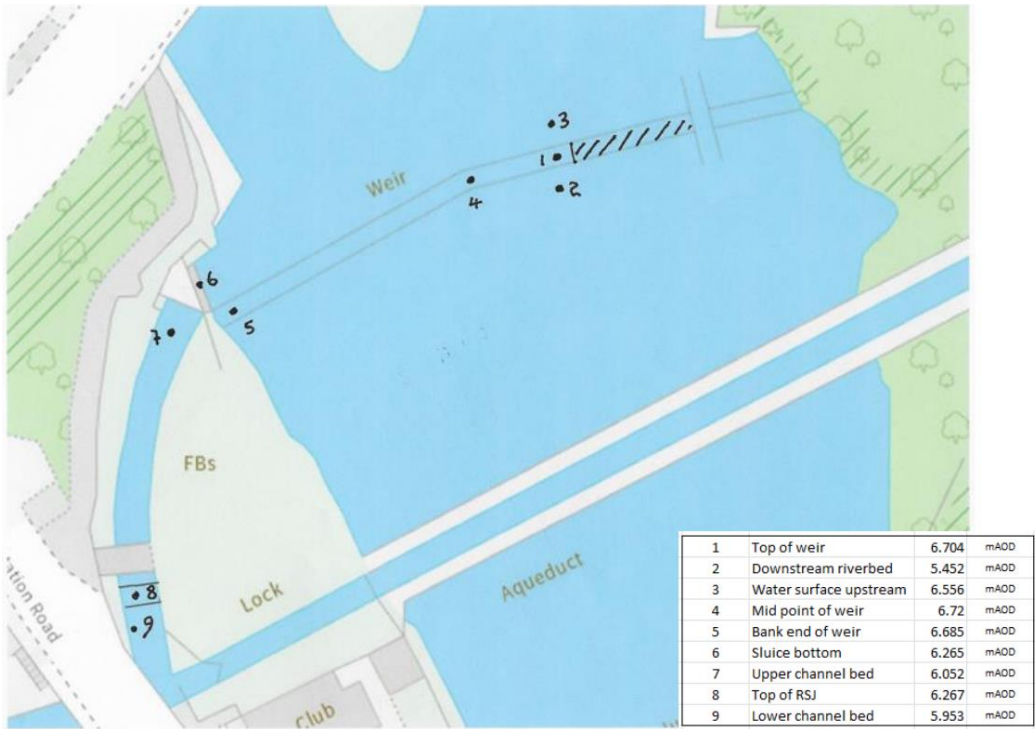
A basic level survey has been undertaken on the existing weir and channels (See Figure 8). This indicates that the existing arrangement currently has the ability to provide water to the Tennant Canal in most, and possibly all conditions.

During relatively low flow conditions the level of the River Dulais appears to be at sufficient top water level to enable flow to enter the channel that feeds the penstock forebay.

This is due to a weir effect at the exit of the River Dulais due to build-up of shale, stone and sediment, raising the water level at the exit from the Dulais above that of the River Neath. This build-up is likely transitory in nature, so it is not clear whether this is a

Figure 7 – Survey showing key levels\*

\* Levels were taken during a survey in February 2022. All levels relate to the weir crest level of 6.72m AOD indicated on record drawings of the fish pass.

reliable longer-term solution without considering the sheet pile reinforcement described in Section 3 a.

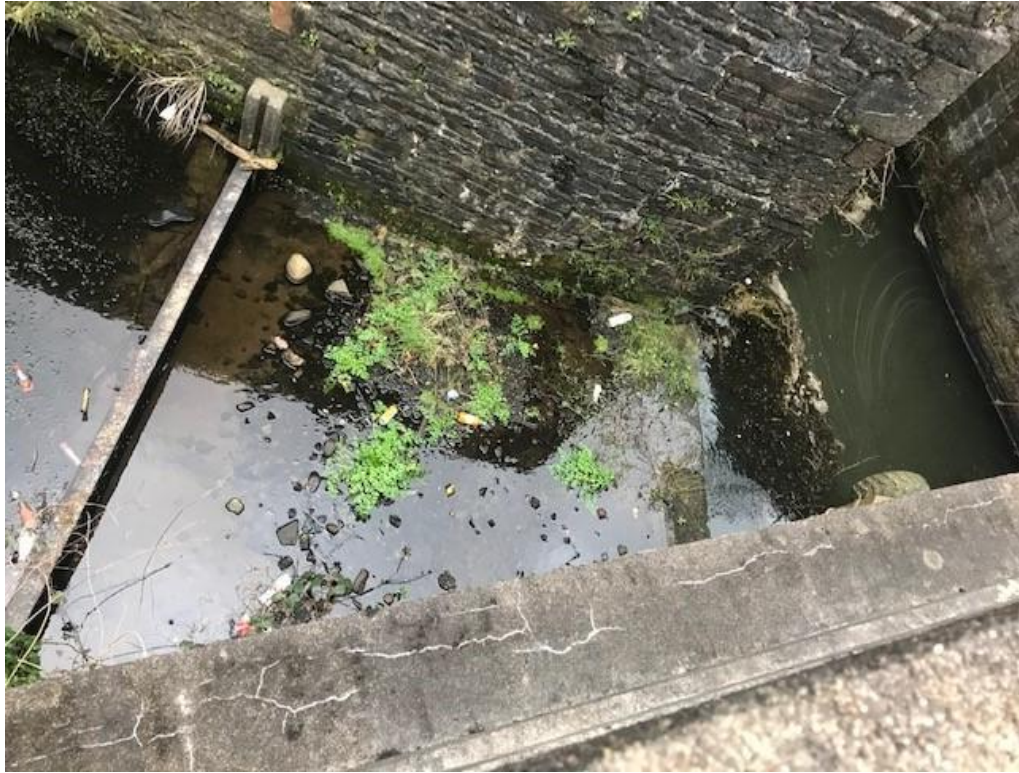
Levels indicate that the Dulais top water level is typically at least 500mm above the level of the bed of the channel feeding the Tennant Canal. The concrete channel feeding the Tennant also contains a small removable control weir immediately before flow enters the canal (see Figure 9). This provides an additional hydraulic loss of around 300mm. However, the remaining 200mm (approx.) head would be still enough to provide flow into the Tennant Canal and the weir could potentially be lowered, or even removed to increase passage of flow.

*Figure 9 – View of exit of channel feeding the Tennant Canal and removable control weir.*
